## TCEQ Interoffice Memorandum

**Date:** September 13, 2017

**Subject:** TX00124 – Spring Lake Dam  
Montgomery County, Texas

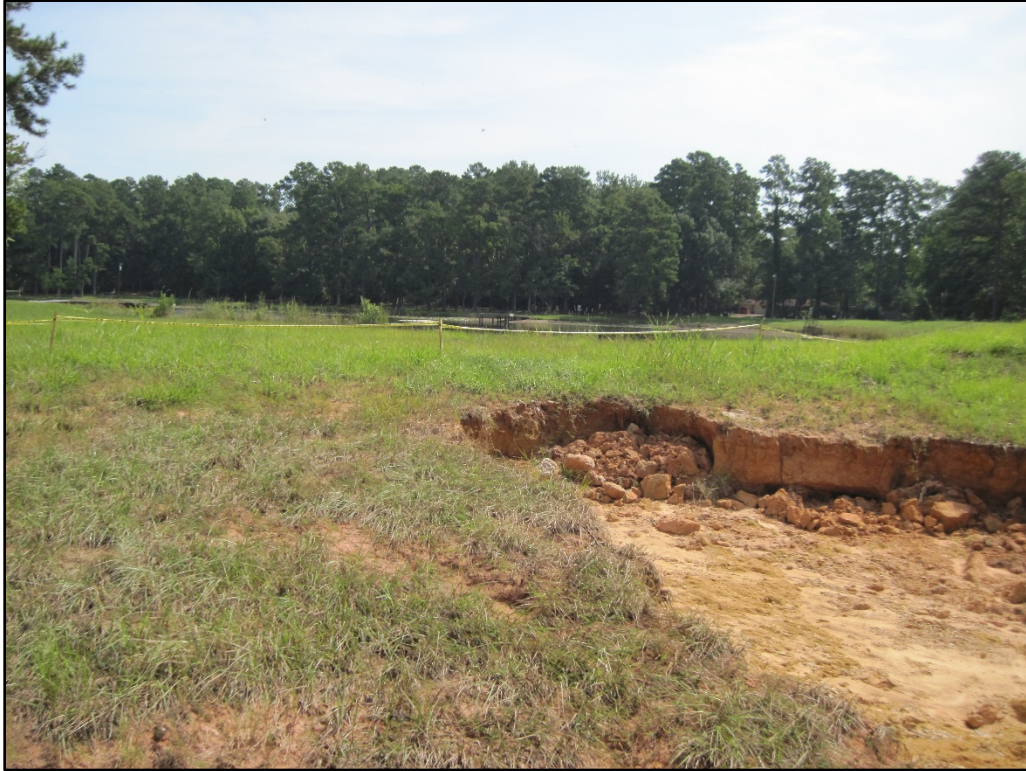
- The downstream slope of the emergency spillway was severely damaged but the spillway did not fail. The headcutting erosion stopped before reaching the crest of the emergency spillway. The depth of cut measured approximately 11 feet. (Photos 1-3)
- The embankment soils at the emergency spillway appeared to be erosive sandy soil.
- Trees in the downstream channel were downed in the storm.
- The rubble riprap observed in the downstream channel was reportedly placed long before the storm – the riprap was not moved by the storm flows – the embankment upstream and to the right of the riprap was heavily eroded. (Photos 4 & 5)

Based on the eyewitness accounts and the inspection observations, the severe damage to the emergency spillway downstream slope began at a steep dropoff of the channel near the riprap. The headcutting erosion worked its way back toward the crest.

**Photo 1:** Downstream slope of the emergency spillway looking upstream toward the reservoir – severely damaged. Note safety tape.

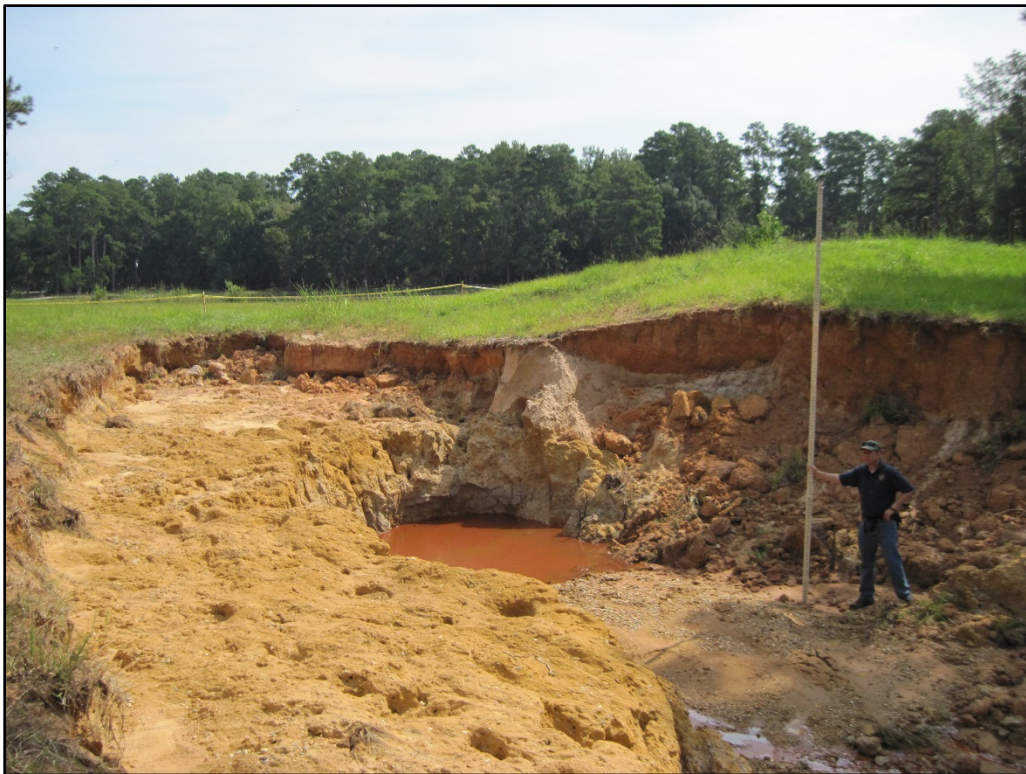
**Photo 2:** Downstream slope of the emergency spillway - the depth of cut measured approximately 11 feet.

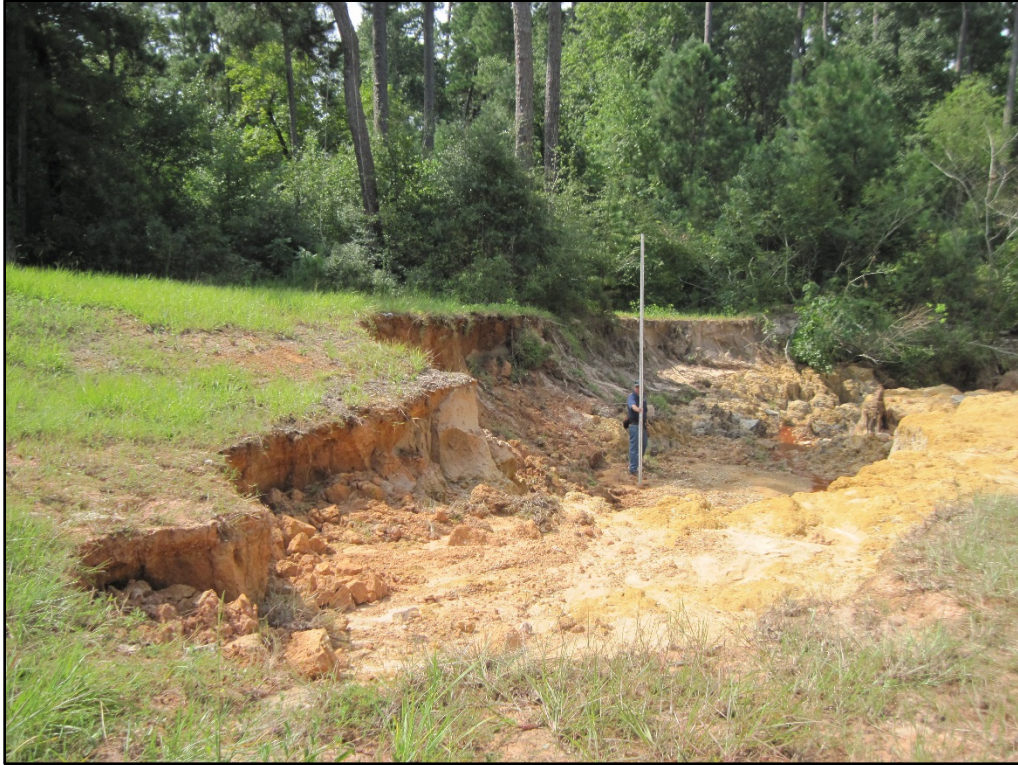
**Photo 3:** Erosion cut on the downstream slope of the emergency spillway, as viewed from the crest of the spillway.

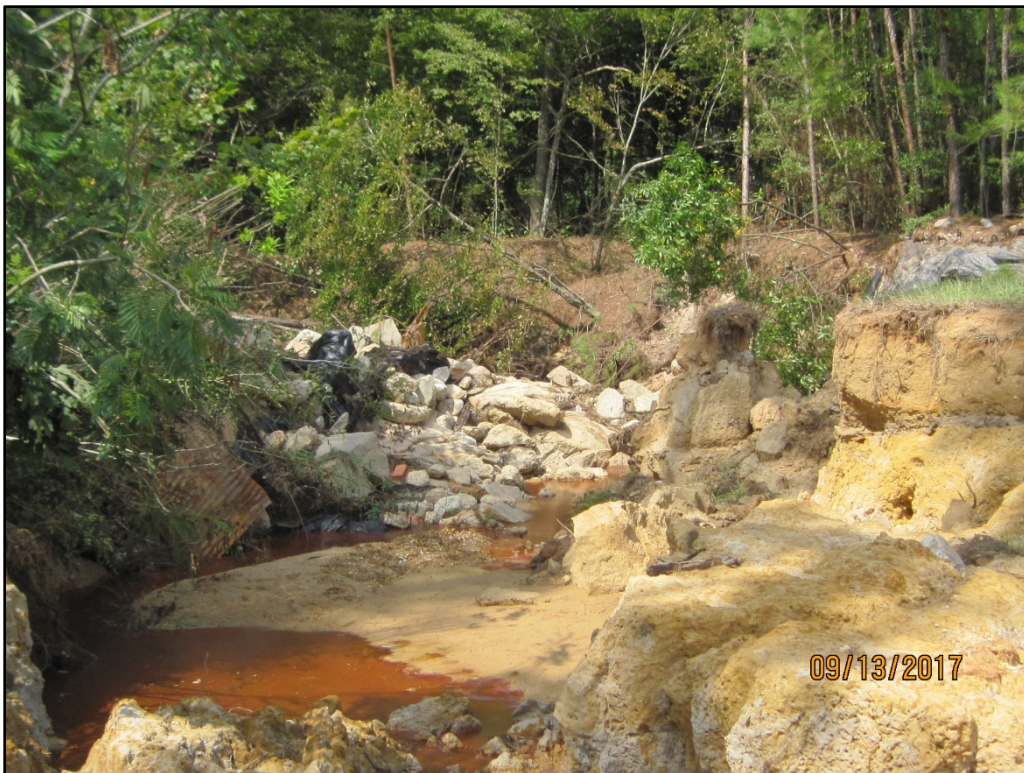
**Photo 4:** Rubble riprap was placed as shown in the photo long before the storm – the riprap was not moved by the storm flows – the embankment upstream and to the right of the riprap was soured away.

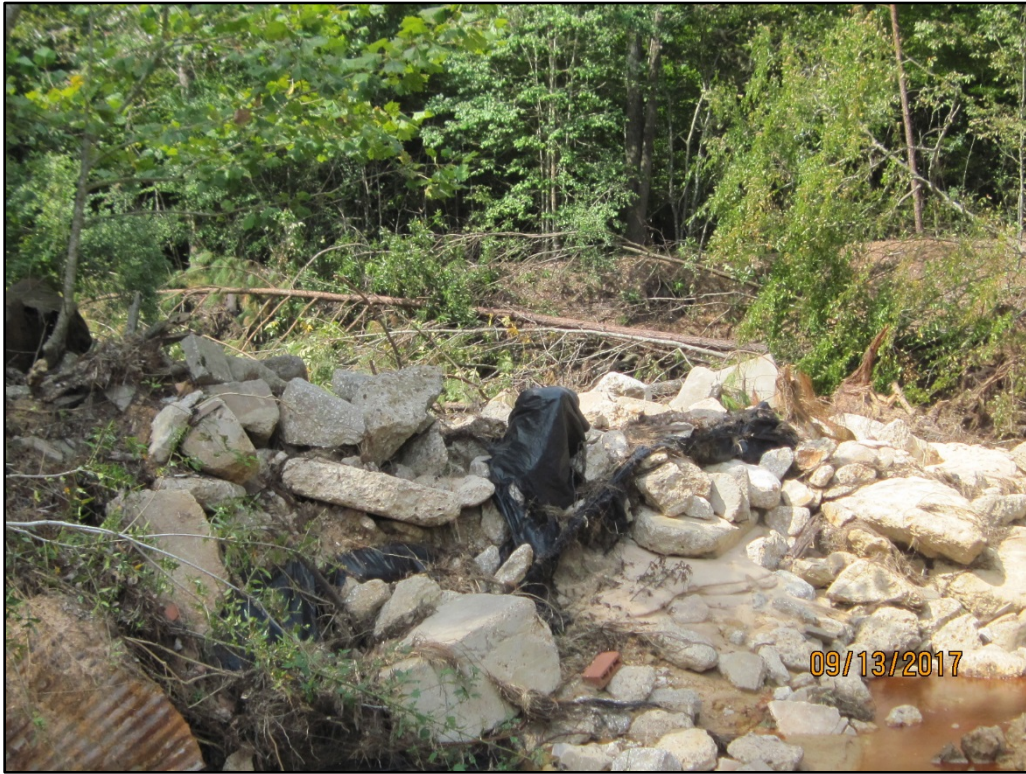
**Photo 5:** Close-up view of the rubble riprap.

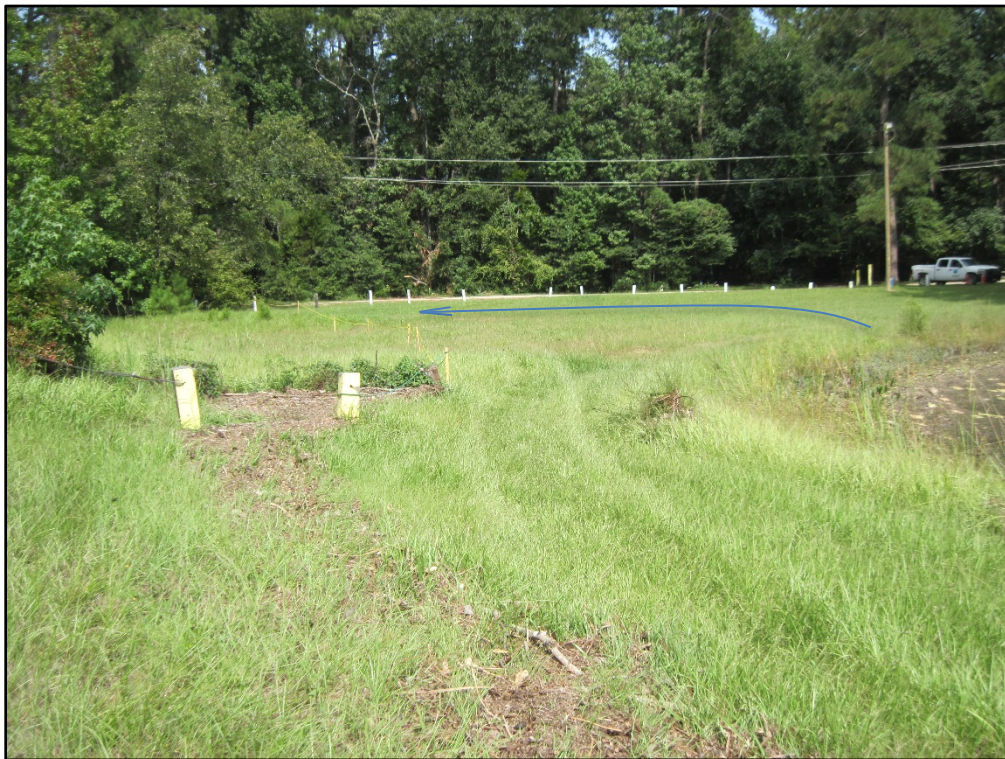
- The debris line suggested the emergency spillway was engaged with approximately 1 foot of flow. (Photo 6 & 7)
- The emergency spillway was undamaged on the upstream slope and crest. This distance was measured by pacing to approximately 45 feet from normal reservoir pool level to the beginning of erosion cut. (Photo 8)

**Photo 6:** Emergency spillway – note debris line.

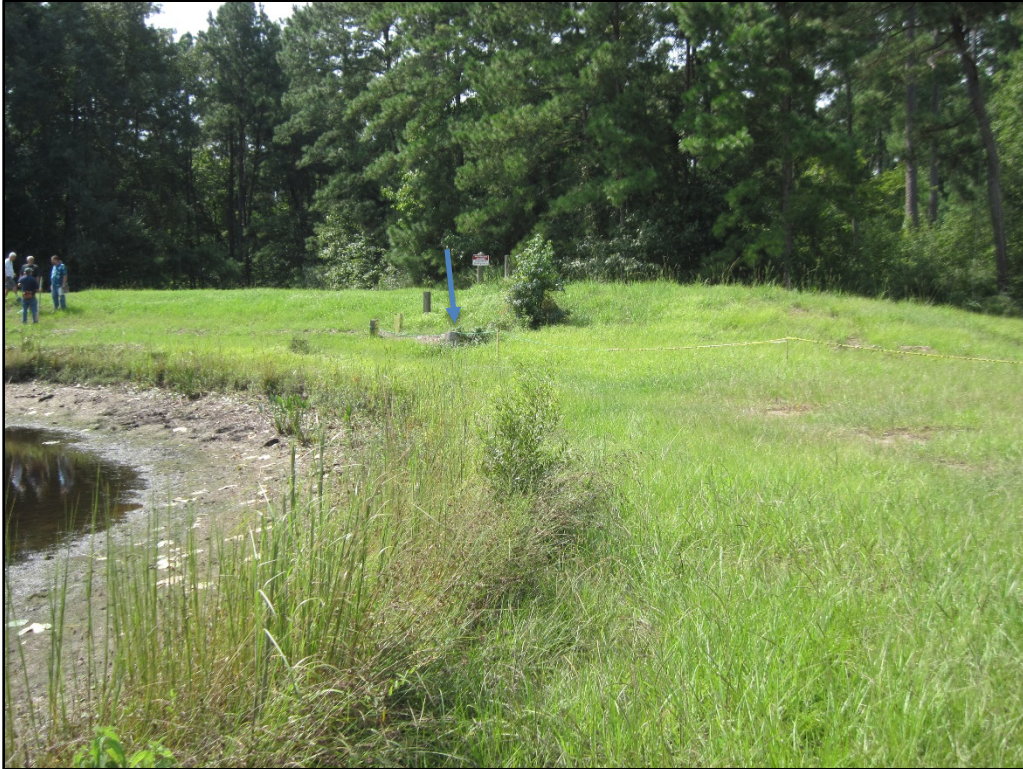
**Photo 7:** Debris line to the left of the emergency spillway.

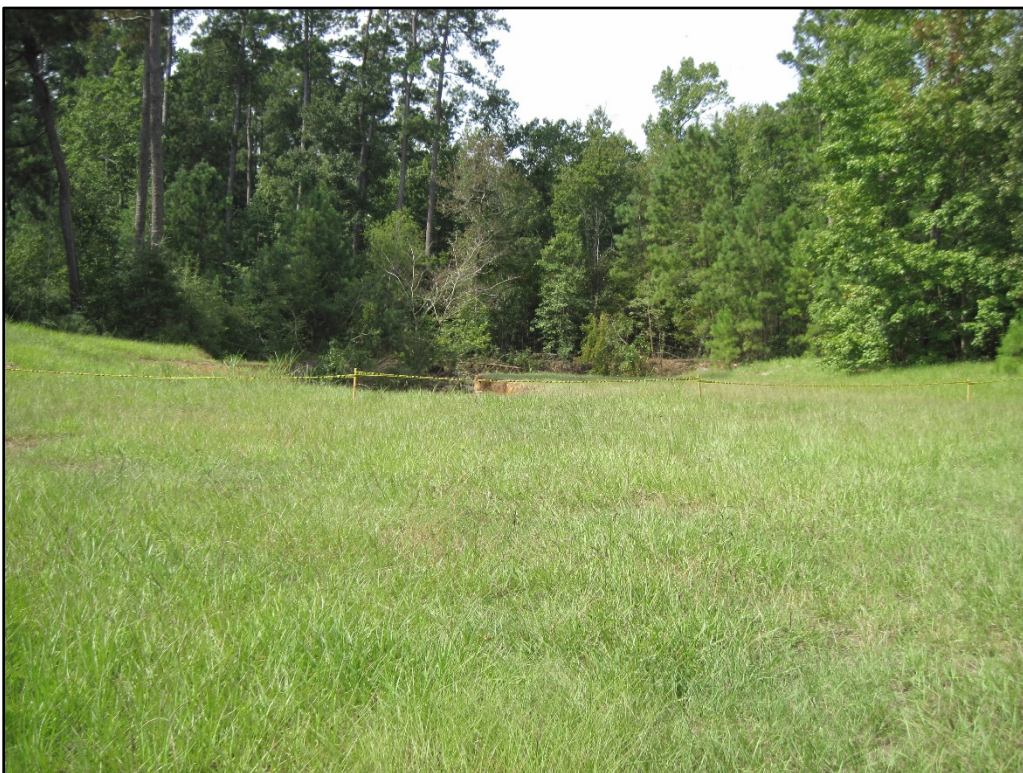
**Photo 8:** Emergency Spillway as viewed from reservoir water line – the downstream erosion cut left approximately 45 feet of the spillway intact.

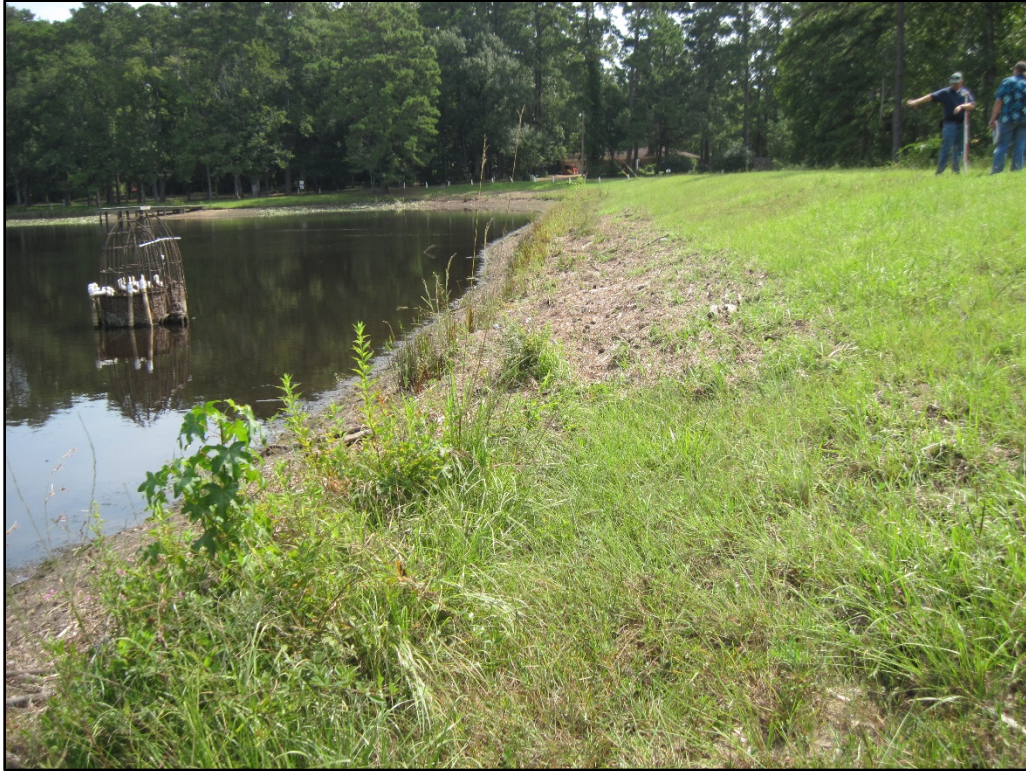
- The debris line was observed at approximately 3 feet below the top of the dam. (Photo 9)
- As a conservative safety measure, the owners lowered the lake level 18" below normal pool with the use of pvc siphons. (Photo 10)

**Photo 9:** Upstream slope – the debris line was observed at approximately 3 feet below the top of the dam.

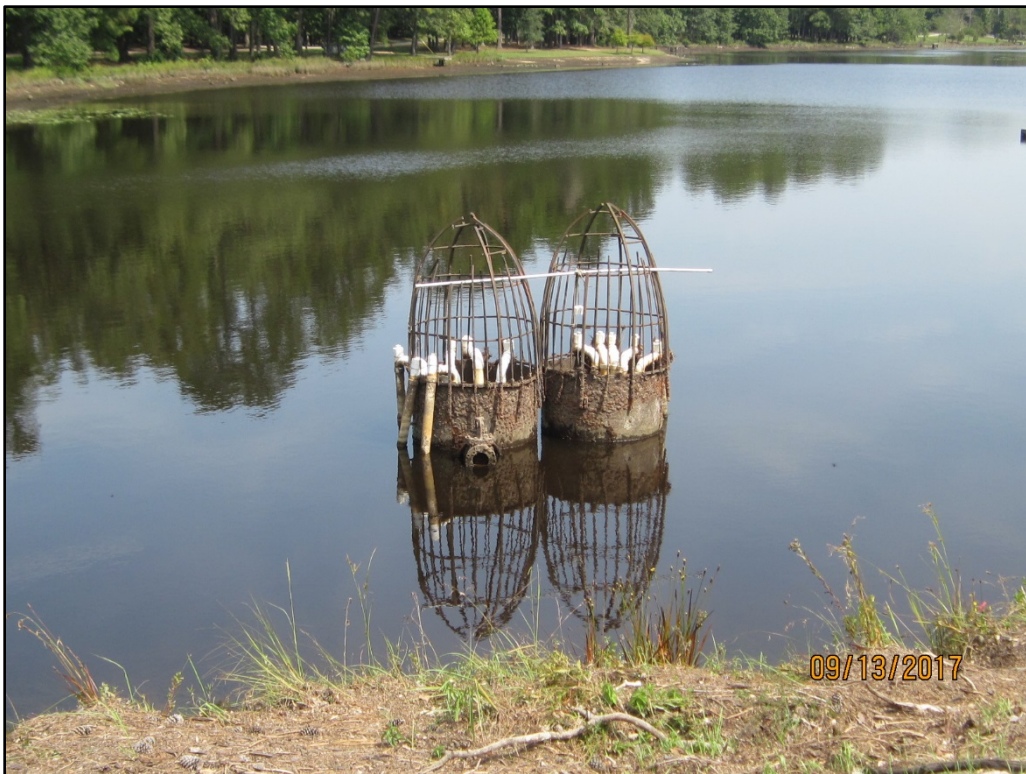
**Photo 10:** Primary spillway inlets. Pvc siphon pipes were used to lower the lake level to 18 inches below normal pool

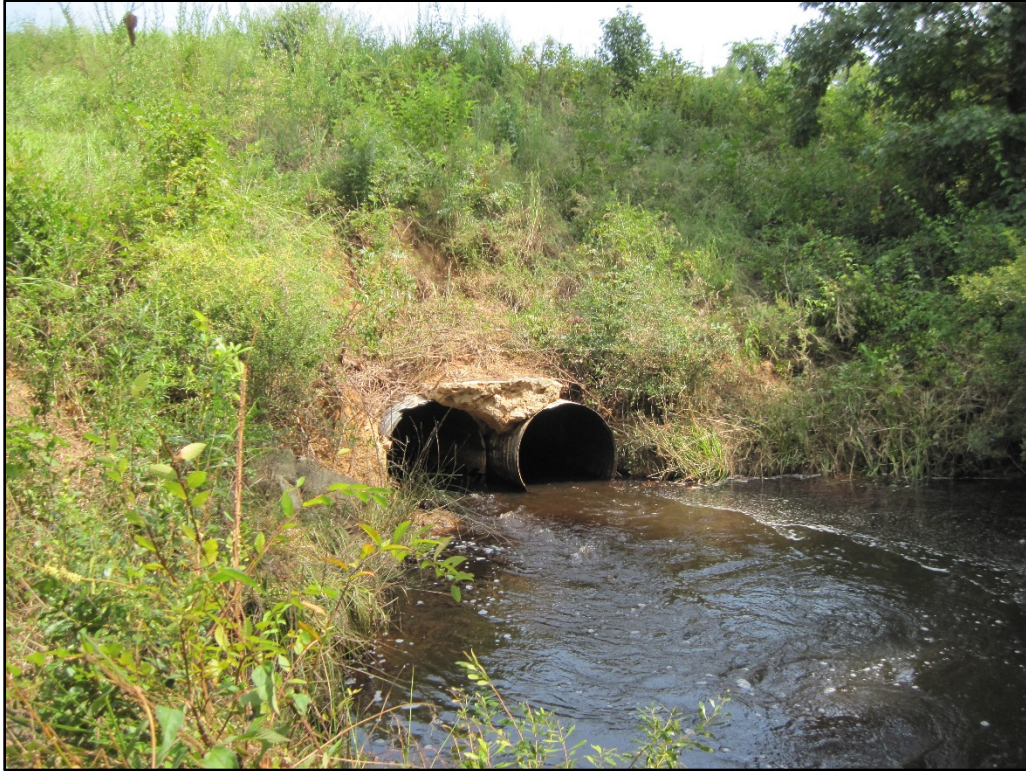
- Some damage was observed on the ends of the primary spillway outfall pipes. Two 48" CMP with some concrete across the tops were observed. The outfall pipes were reportedly submerged during the storm and water shot up forcefully at the outfall. (Photo 11)

**Photo 11:** Primary spillway outlets pipes incurred minor damage to the ends of the CMP. The outfall pipes were reportedly submerged during the storm and water shot up forcefully at the outfall.

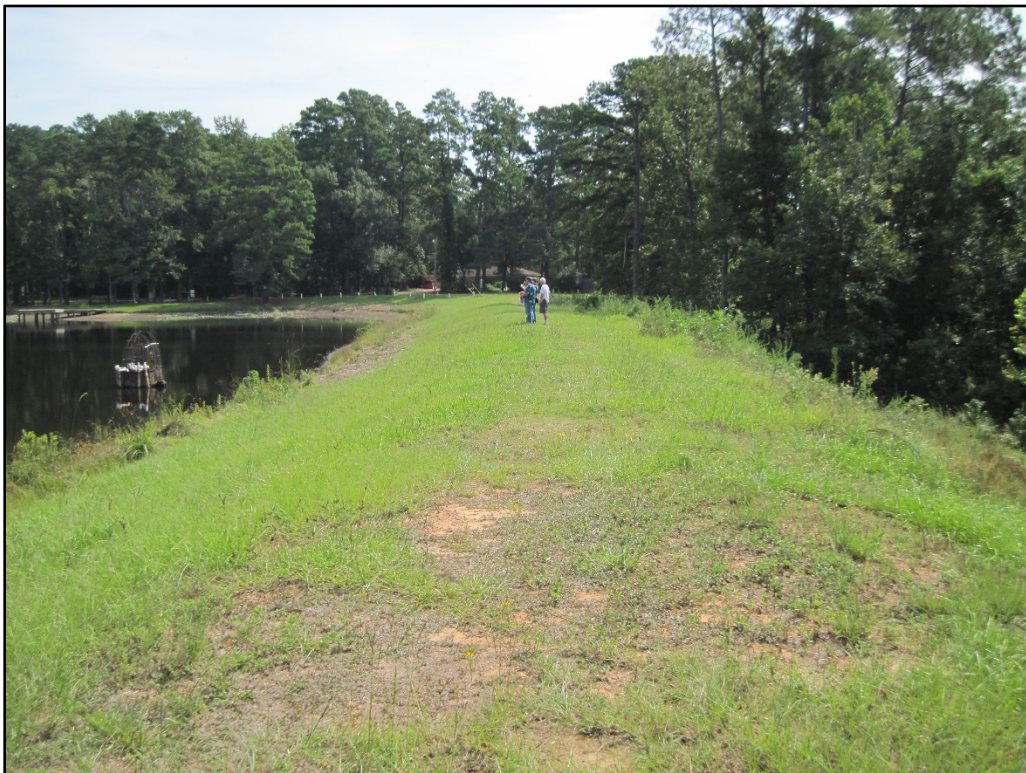
**Photo 12:** Crest of the dam – the POA noted that they plan to address the bare spots by adding top soil and seed.

- Some bare spots were observed on the crest. POA noted that they plan to address this by adding top soil and seed. (Photo 12)
